# Manhole Inspection Summary

Manhole # S4700\_003MH

Insp Date: **2/25/10 2:04 PM**

**Location** Address: **Sinclair Ln**

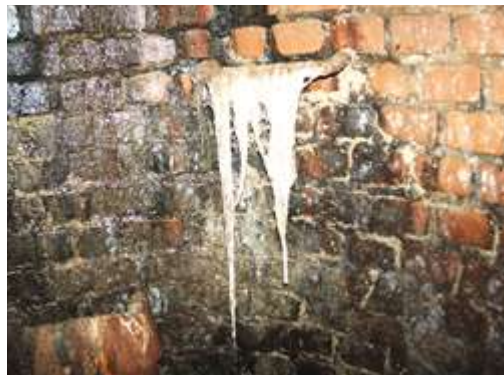
Defect 3

evidence of surcharge

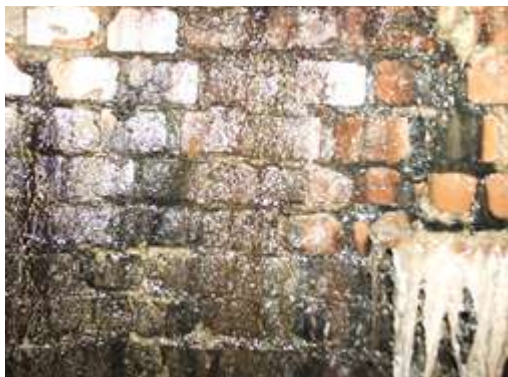
Defect 2

Condition: ☐ Sound ☒ **Cracked** ☐ Root Intrusion ☐ Loose Brick ☐ Deteriorated

Infiltration: ☐ None ☐ Joint ☒ **Cracks** ☒ **Mortar** ☐ Roots ☐ Wall

infiltration

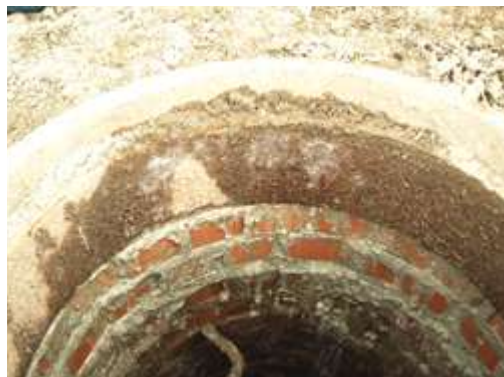
Defect 1

☒ **Leaks**

frame leaks

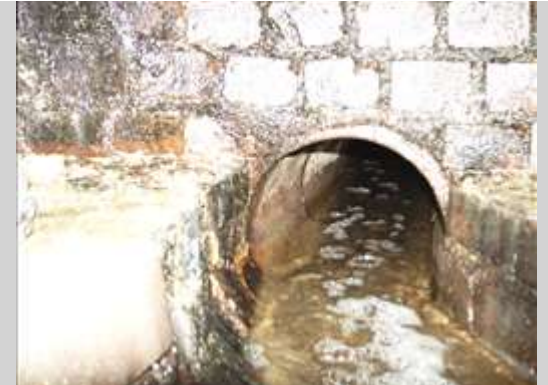
12 O'Clock Outflow

Pipe Height: **14.4** (in.) Rod and Bar (Angled)  
Pipe Material: **Clay** ☐ Pipe Lined  
Invert Depth: **14.67** (ft.) Flow Characteristics: **Fast**  
Deposits: ☒ None ☐ Mud ☐ Sludge ☐ Debris ☐ Grease  
Silt Depth: (in.) Deposits Extent:  
Infiltration: **None** Pipe Seal Cond: **Sound**

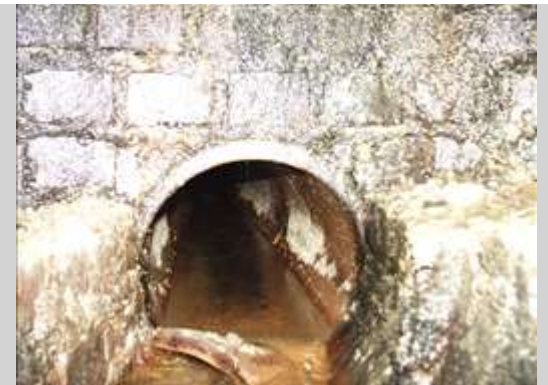
3 O'Clock Inflow

Pipe Height: **14.4** (in.) Rod and Bar (Angled)  
Pipe Material: **Clay** ☐ Pipe Lined  
Invert Depth: **14.58** (ft.) Flow Characteristics: **Slow**  
Deposits: ☒ None ☐ Mud ☐ Sludge ☐ Debris ☐ Grease  
Silt Depth: (in.) Deposits Extent:  
Infiltration: **None** Pipe Seal Cond: **Sound**

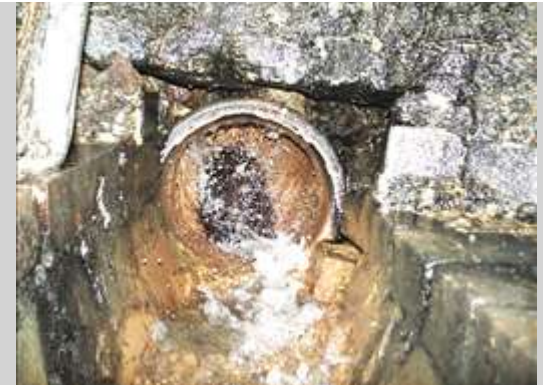
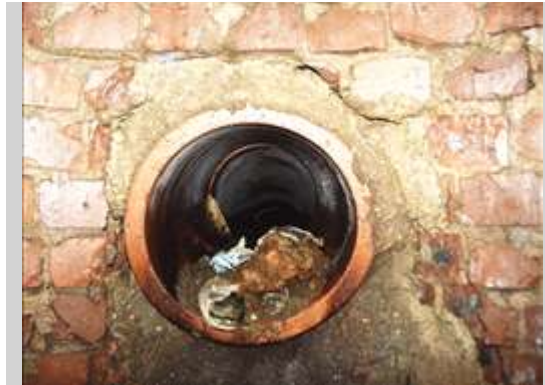
6 O'Clock Inflow

Infiltration: **None** Pipe Seal Cond: **Sound**

Drop: **Outside** Rod and Bar

Drop Condition: **Open**
